US EPA Region 8
Enforcement Compliance & Environmental Justice Division
RCRA Compliance Evaluation Report

Date of Inspection: March 7, 2014

Facility Name: US Magnesium LLC

**US Magnesium
Skull Valley, Utah
UTD000690867
RCRA Compliance Evaluation Inspection**

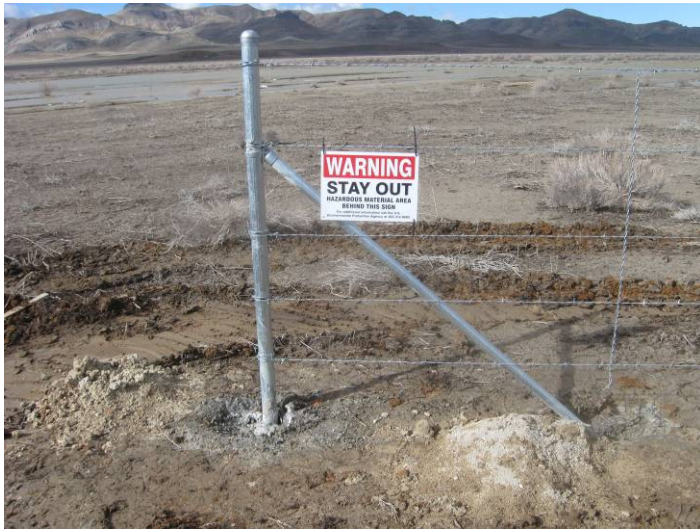
Photograph 1. This picture shows the corner post on the southeastern portion of the fence, north of the spill. The sign is labeled with wording required under the order.

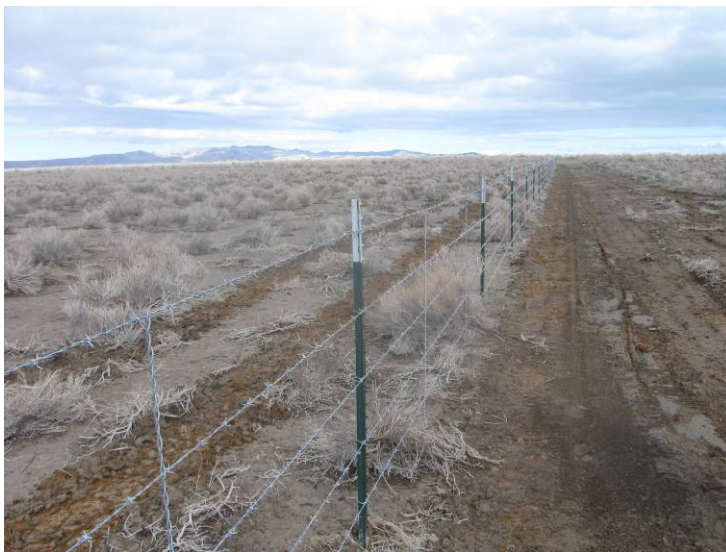
Photograph 2: Photo is taken from the east side of the fence, pointing northerly.

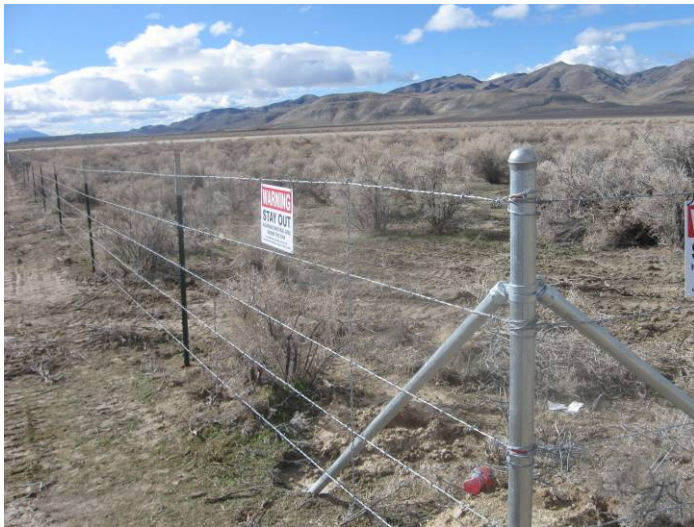
Photograph 3. Photo is taken from the northeast corner of the fence, pointing in a southwest direction. The fence consists of a five string barbed wire, sufficient to keep cattle out, with appropriate signage.

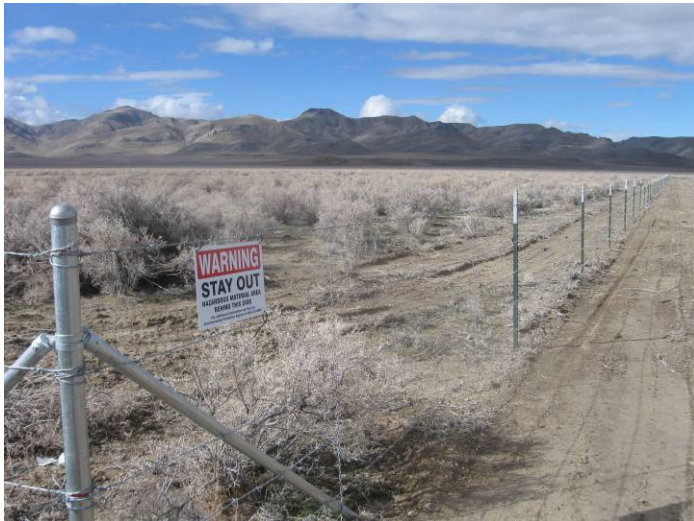
Photograph 4. This photo is taken from the northeast corner of the fence, pointing in a westerly direction.

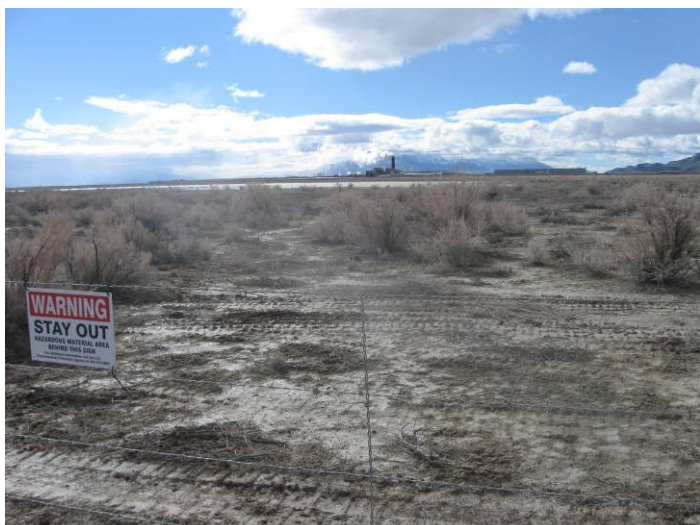
Photograph 5. This photo was taken from the north side of the fence. The majority of the exposed land appears to have been previously covered by wastewater from the spill.

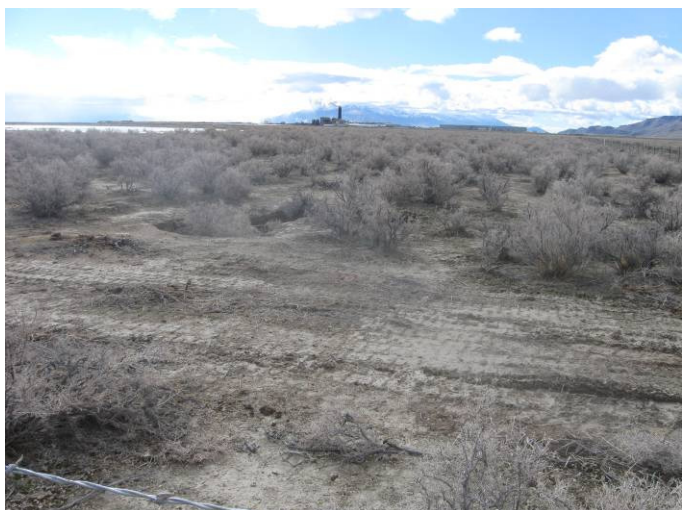
Photograph 6: This area is within the fence, looking in a southwestern direction. This area appears to have been previously covered by acidic water. There appears to be cavitation in some portions of the land surface.

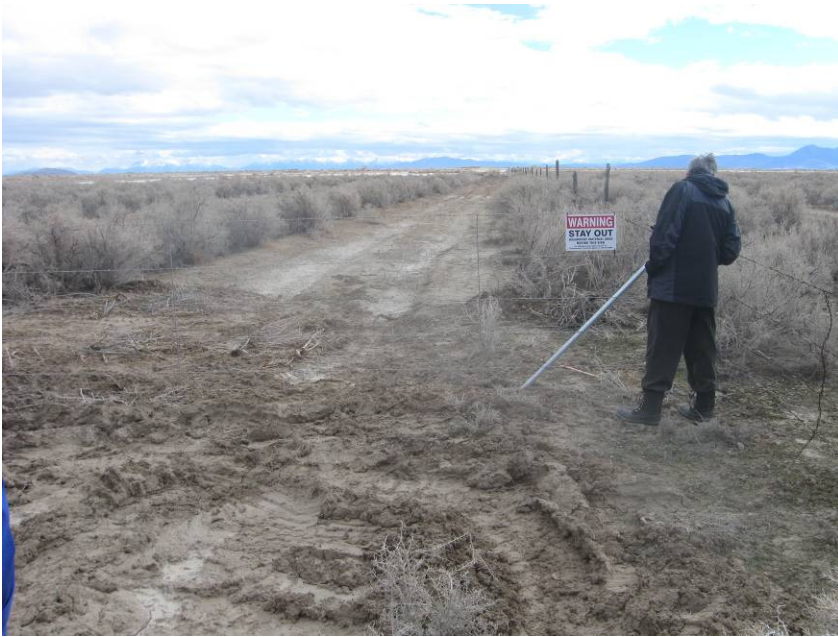
Photograph 7: This photo was taken from the southwest corner of the fence, looking east. The newly constructed fence ties into the existing east-west fence.

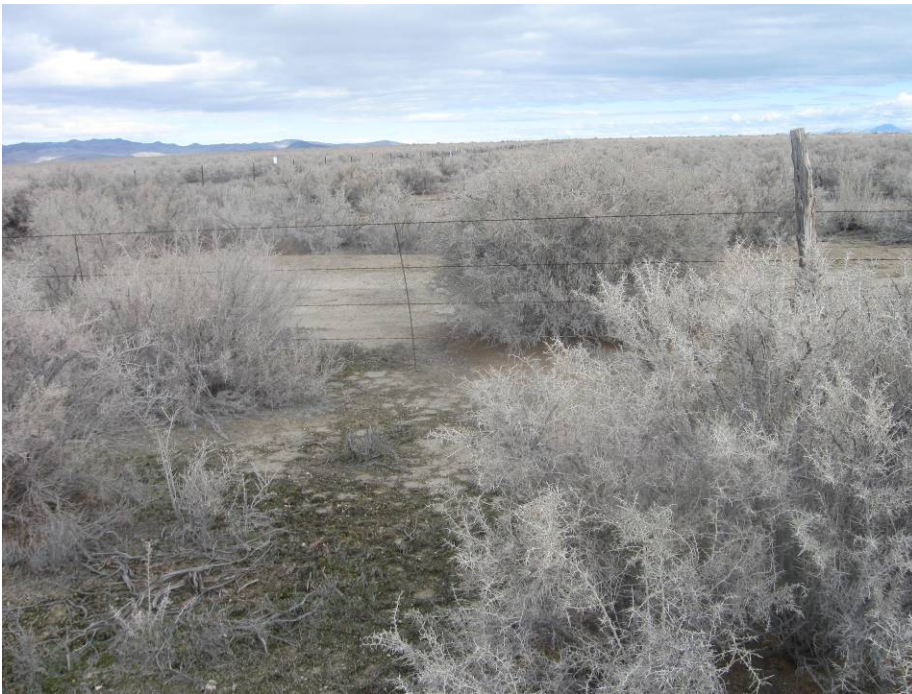
Photograph 8: This photograph was taken from the southern side of USM existing fence, pointing in a northwest direction. The newly constructed fence that is the western boundary is also shown in this picture.

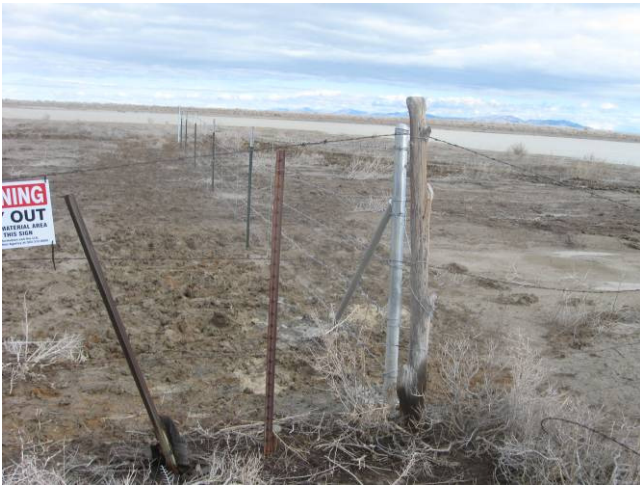
Photograph 9: The photo is taken on the southeast side of the fence. Additional fencing was added from the existing fence to further restrict access.

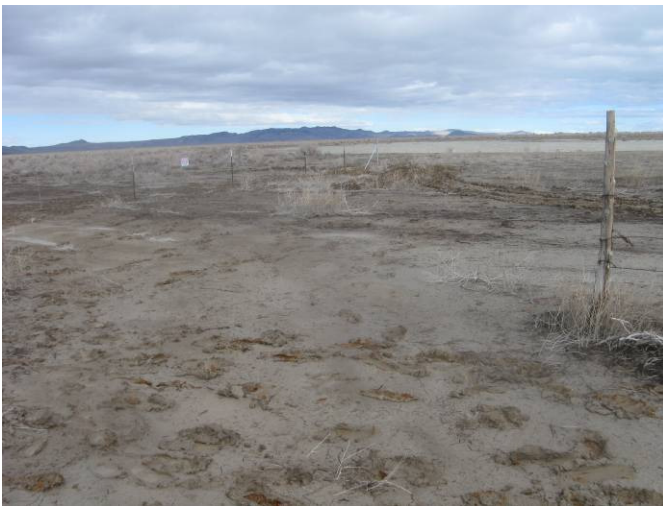
Next, Mr. Gibby drove us to the Phase 1 project area located north of the USM production plant. We entered the project area from the east. We walked around the circumference of the fence installed by USM, starting north of the spill from the southeast side (see Photograph 1), proceeding north (see Photograph 2), then west (see Photograph 3), south and returning easterly. All portions of the spill on BLM land appeared to have been adequately fenced per requirements of the order. The fence consisted of five strand barbed wire sufficient to keep cattle out. Signs were posted every 150 ft. labeled with the appropriate wording (See Photographs 1-5.) It appeared that the pond had receded significantly. (See Photographs 5 and 6.) The newly installed fence was tied into an existing fence that followed an east-west road located south of the spill area. (See Photographs 7 and 9.) Most of the existing fence was in good condition. (See Photograph 8.) I observed one gap, approximately 10-15 feet wide, east of BLM's

Photograph 10: Photograph shows a gap between the newly constructed and existing fences.

property, between the newly constructed fence and an existing fence. I asked Mr. Gibby if he would close this gap with appropriate wire. Mr. Gibby stated that USM would comply with this request. This work is not a required under phase 1 of the order.
